# *Robert Andrys Architect and Inspections*

## **Property Condition Report**

xxxxx, Jamestown, TN 38556  
Inspection prepared for: Jane Doe  
Date of Inspection: 9/16/2016 Time: 10:00 AM  
Age of Home: Built 2009 Size: 1440 s.f.

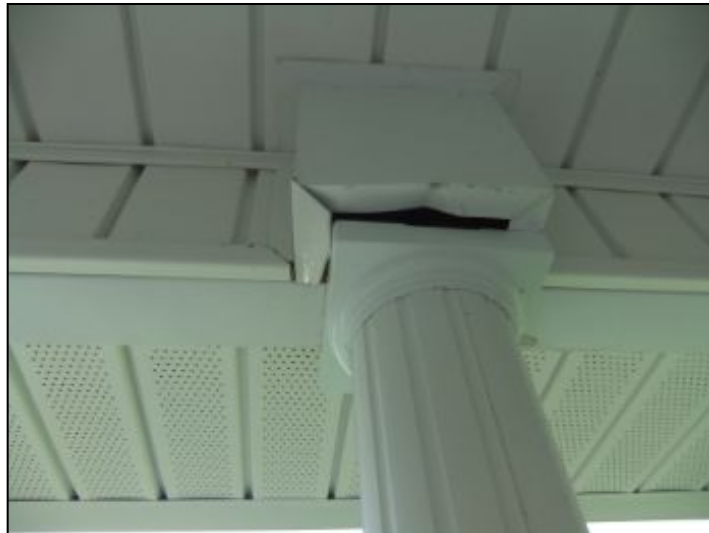
Trim bent

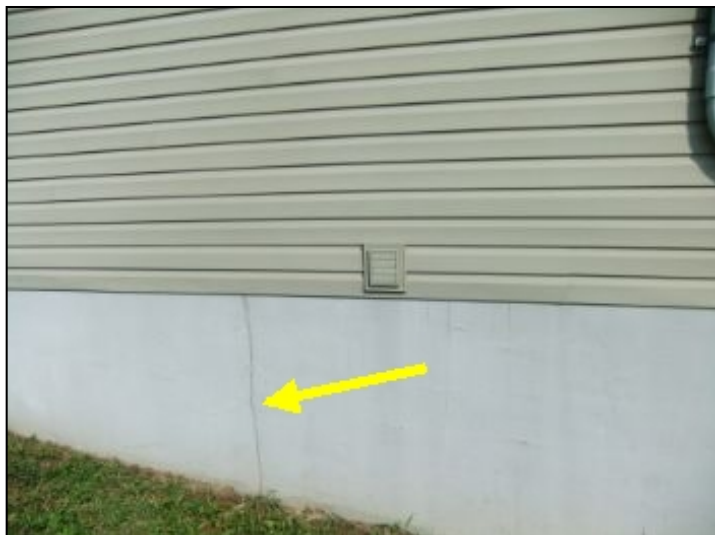
Crack in parge coating

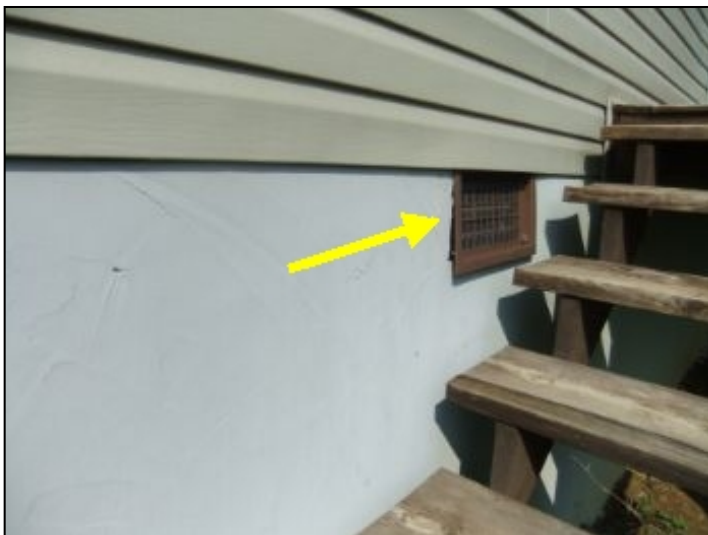
Vents are loose and can allow insects to enter crawlspace. Tighten and seal vents.

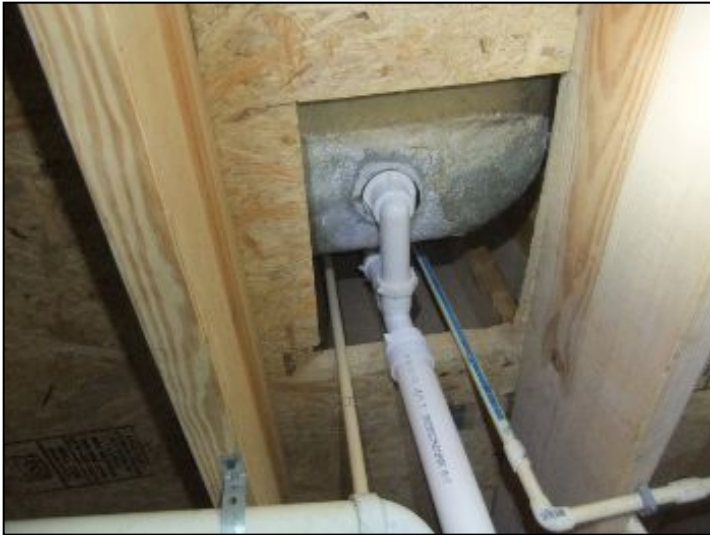
- Appears serviceable
- Although serviceable as is, there is no insulation along the block wall of the crawlspace. This leads to higher energy bills. Vents should be closed during winter.
- **The subfloor under both of the bath tubs/showers has been cut out to install the plumbing. These cutouts should be closed off with plywood to keep the moist hot summer or cold winter air from coming into the upper part of the house. Apply sealant around the pipes and seams for a good air barrier.**

Replace subfloor

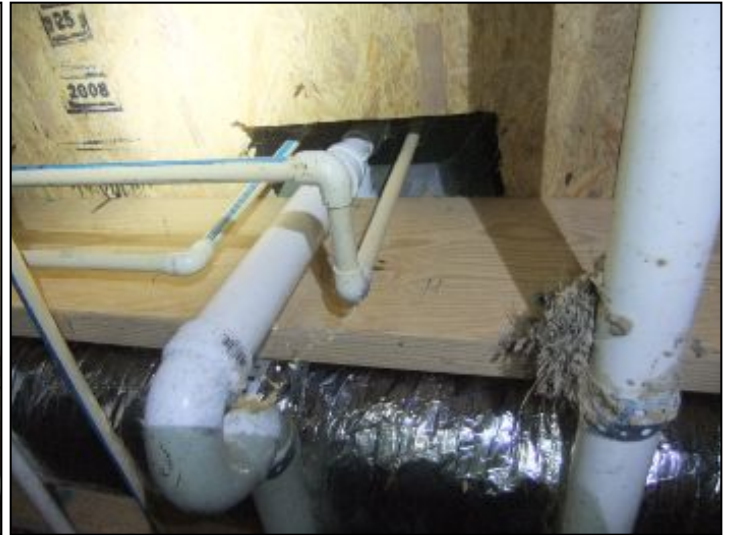
Replace subfloor

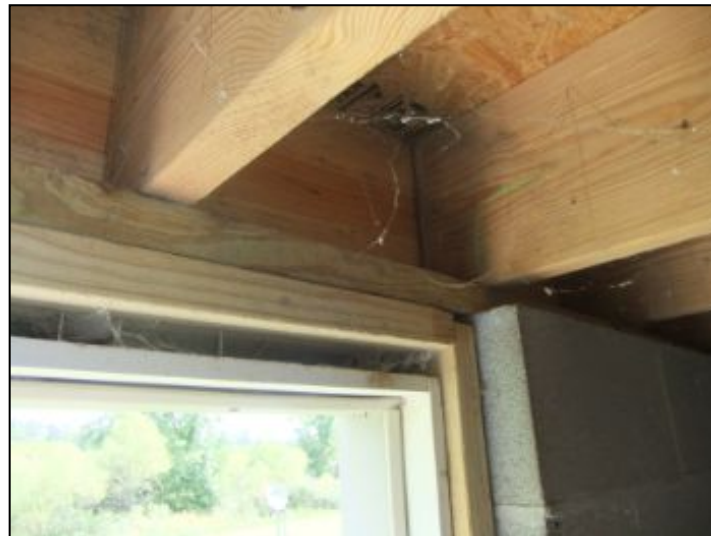
- Appears serviceable
- There is no beam over the door going into the crawlspace. Currently there is only a 2x6 plate that is supporting the floor joists. I did not see any deflection in the plate or sagging of the joists but over time this might occur. A beam of some kind should be installed to support these floor joists.

No beam above crawlspace access door

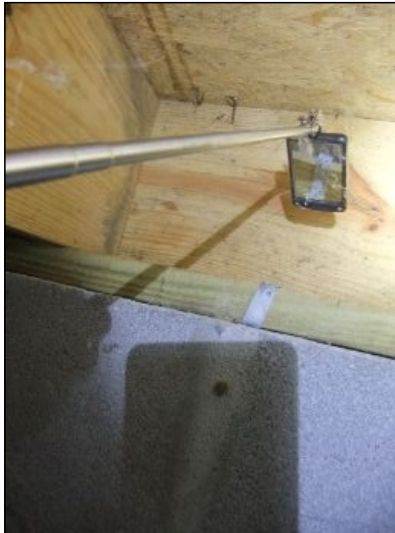
No nails in straps holding plate to block

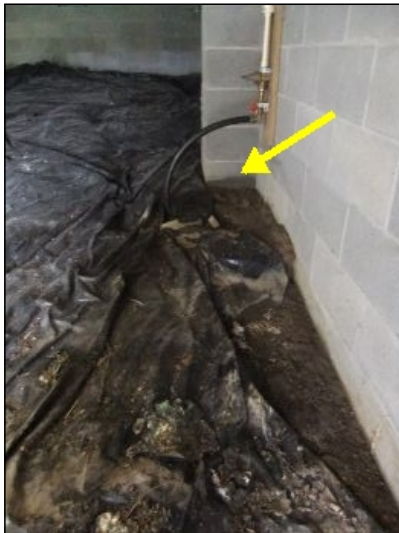
- Symptoms of prior and current water entry exist. Standing water was seen on the plastic. It is evident that water is not draining out of the crawlspace in a timely manner. The downspouts from the roof gutters spill out next to wall and one is no longer hooked into the plastic drain all allowing water to enter crawlspace.

Lots of moisture on block and dirt

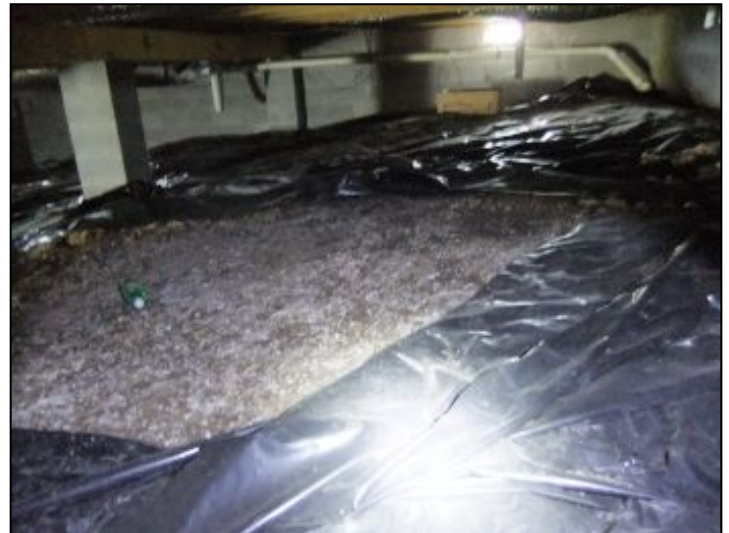
- Full moisture barrier in place
- A moisture barrier is present but is pulled apart in many areas and seams were not taped. All earthen crawlspaces must have a proper moisture barrier installed to help keep water vapor from entering the crawlspace area. Repair/replace as needed.

missing plastic sheeting

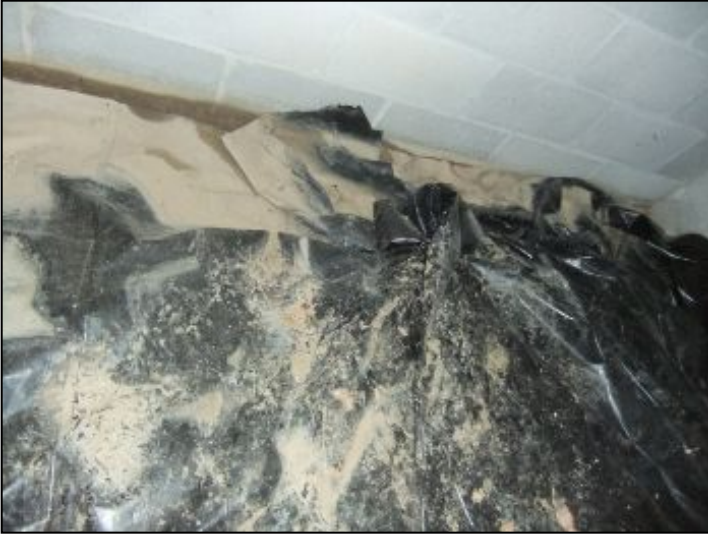
Signs of standing water at back of crawlspace

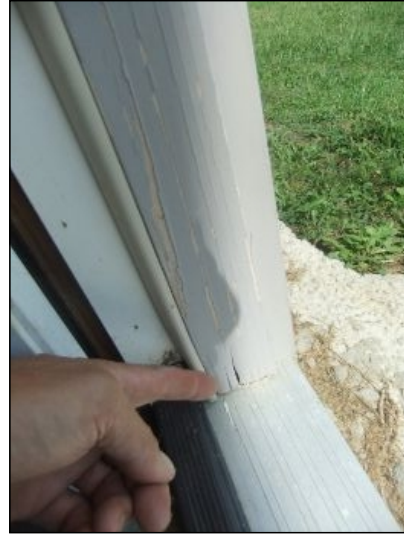
Jamb of access door needs repair

- Appears serviceable
- Rot at the lower parts of the door frame/jamb at crawlspace door. Repair all rotted wood.

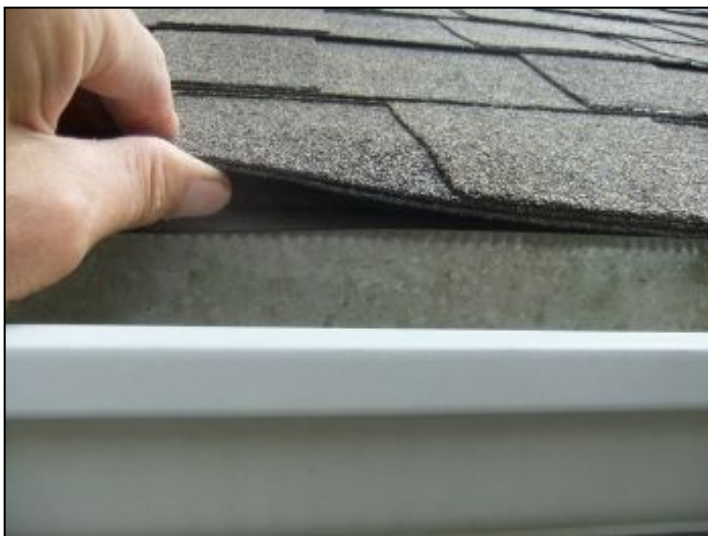
- Appears serviceable
- There was no **drip edge** installed, which is common in this area but can allow the roof sheathing to get wet under heavy storm conditions.

No drip edge.

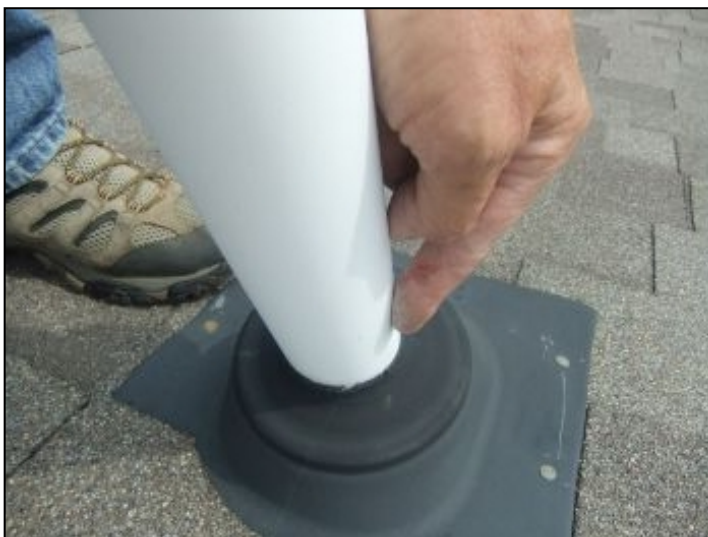
- The rubber boot flashing around the plumbing vents do not have a clamp on them and a gap is present on one of the two boots. Clamps must be installed. Note: These boots have a typical lifespan of around 5-7 years. When it starts to crack or split they will need to be replaced otherwise you will have water dripping into your home. It is best to be proactive and replace them before they really need it.

Missing clamp at boot #1

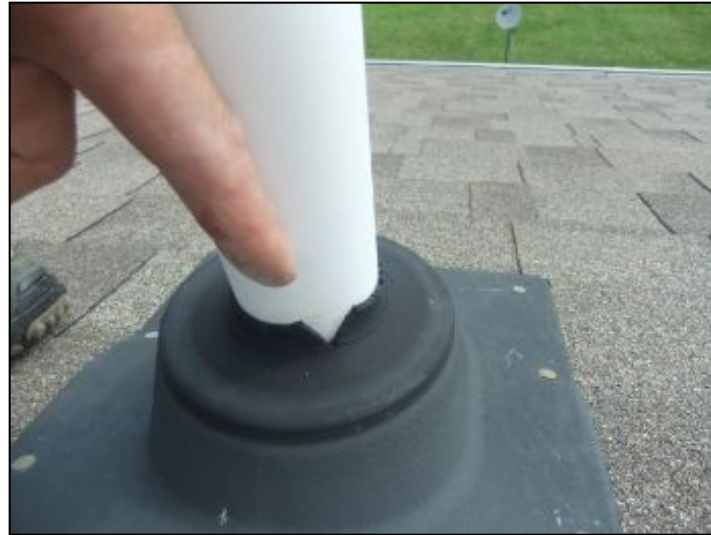
#2 boot starting to split and missing clamp

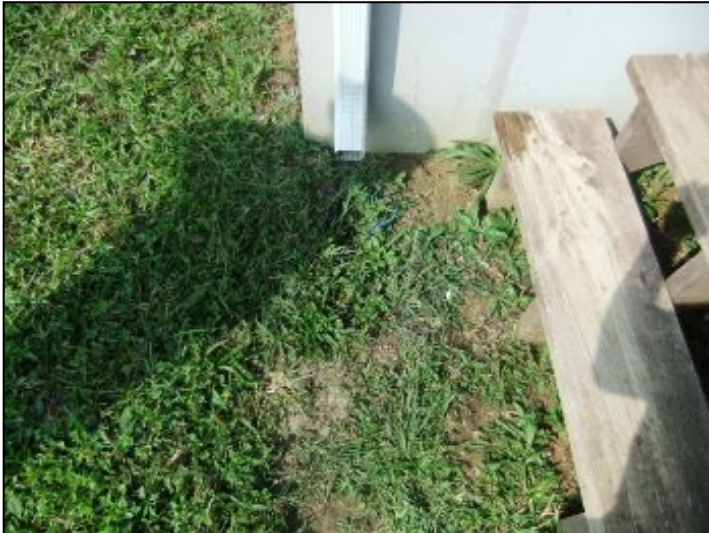
Downspout should be redirected away from bottom of stairs to eliminate slick or icy conditions.

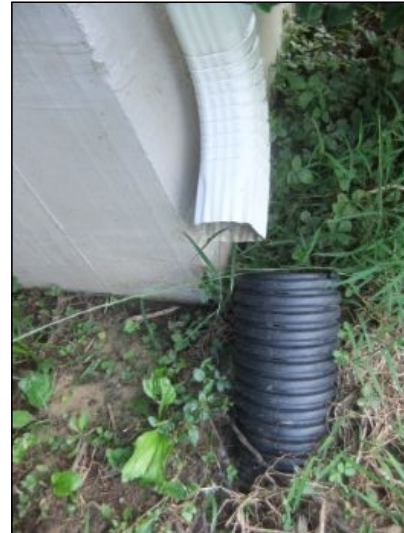
- Appears serviceable
- No splash block under downspout.
- Route downspouts away from the building. This will help with the water entering the foundation.
- I found one of the subsurface drains not properly connected to the downspout(s). The drains need to be properly connected and draining the water away from the foundation of the home. If this is not done water can and will most likely collect in the crawlspace.

missing connector to drainage pipe

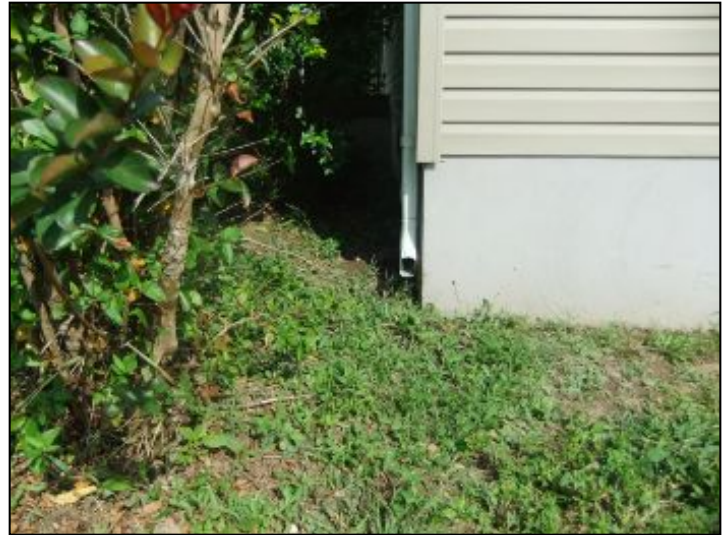
Downspout extension needed. Turn downspout so  
water flows away from house.

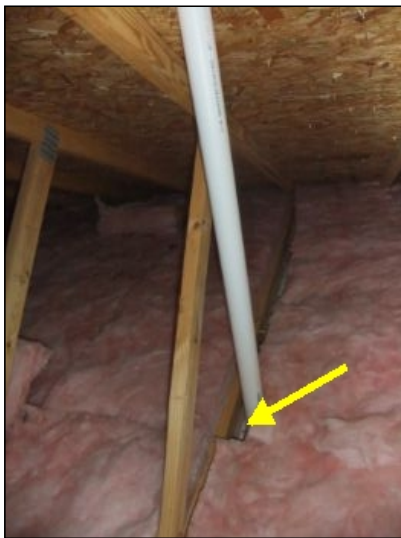
- A small piece of insulation was missing above the second bathroom.

Missing insulation above master bath

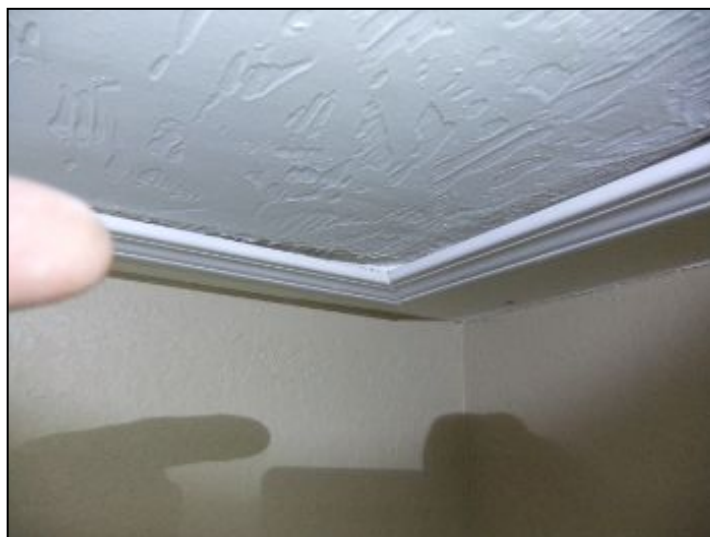
Attic access needs to be trimmed to allow better, tighter fit

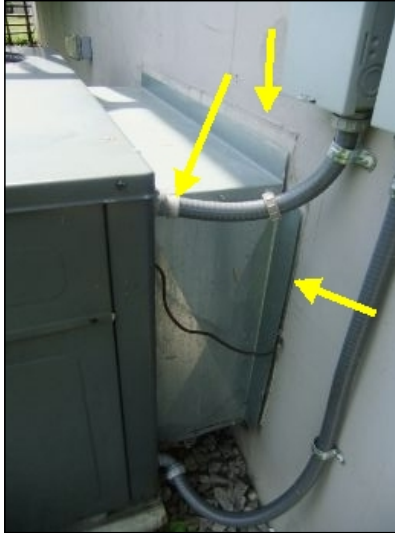
Reseal ductwork to house and reattach conduit nut

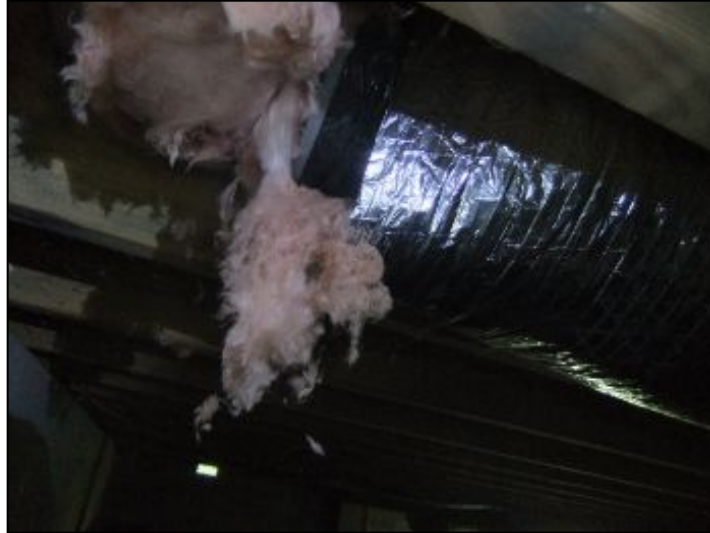
- Appears serviceable
- Minor retaping of the duct insulation is needed at two of the boots at the front of the house in the crawlspace.

Boot insulation needs to be repaired

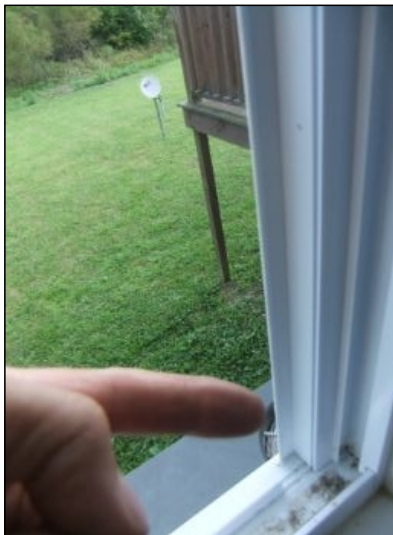
- Appears serviceable
- Window screens are missing on windows.

No screens

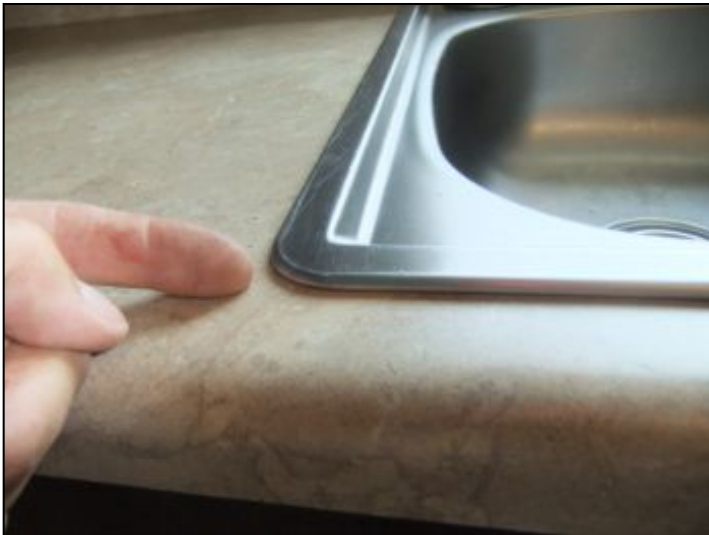
- Faucet is serviceable, sink needs sealant and to be re-attached to countertop
- Waste lines under sink once were leaking, no leaks were found at time of inspection. The sink cabinet is covered in mold. This mold must be cleaned out and decontaminated in a proper manner.

Sink is loose and has no sealant under rim

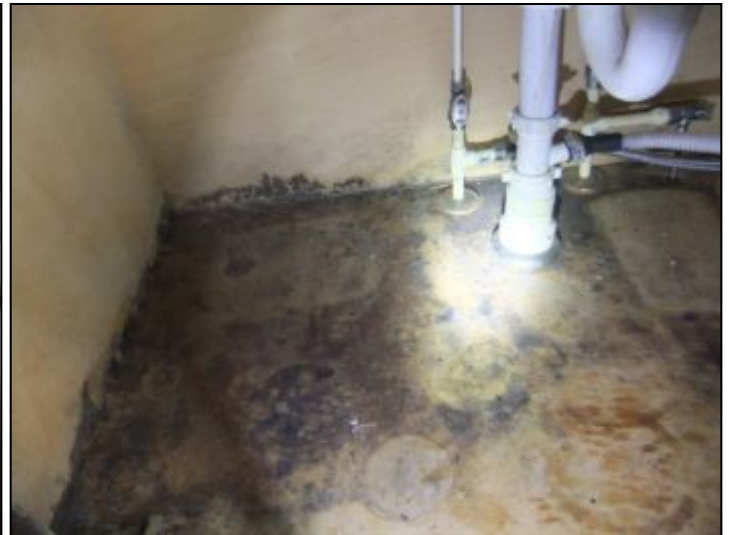
Mold in cabinet

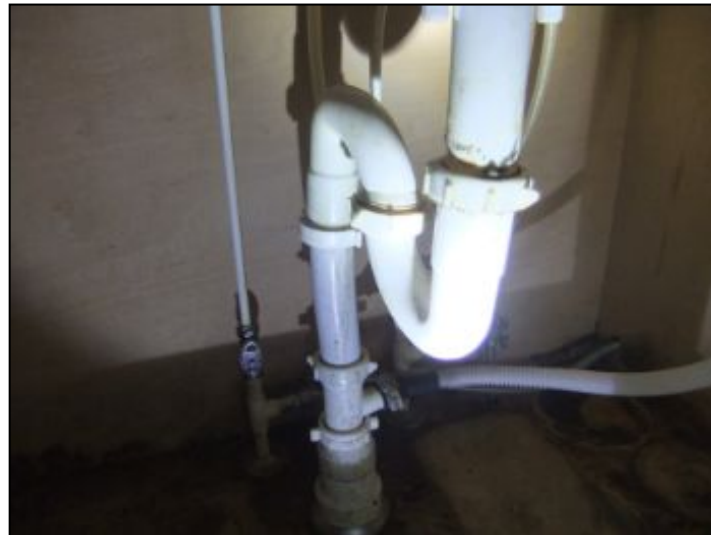
Drain used to be leaking here

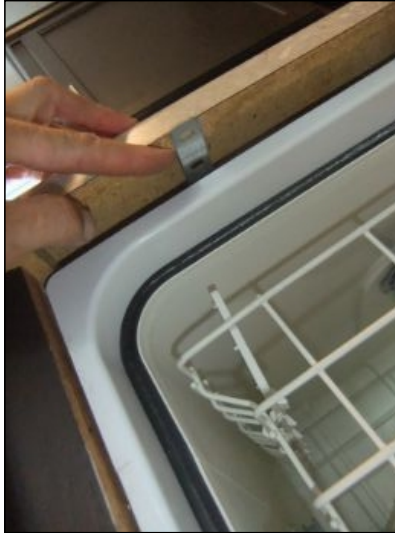
- Appears serviceable, ran unit through a wash and dry cycle.
- Unit is not secured to the counter or cabinet. All dishwashers need to be secured so that they can not be moved as excessive movement can cause leaks.

Dishwasher not fastened to countertop

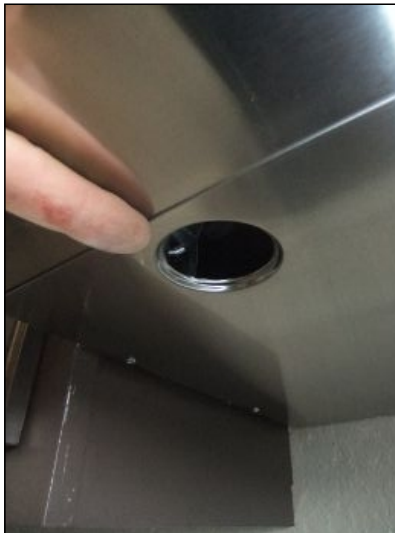
Missing light bulbs

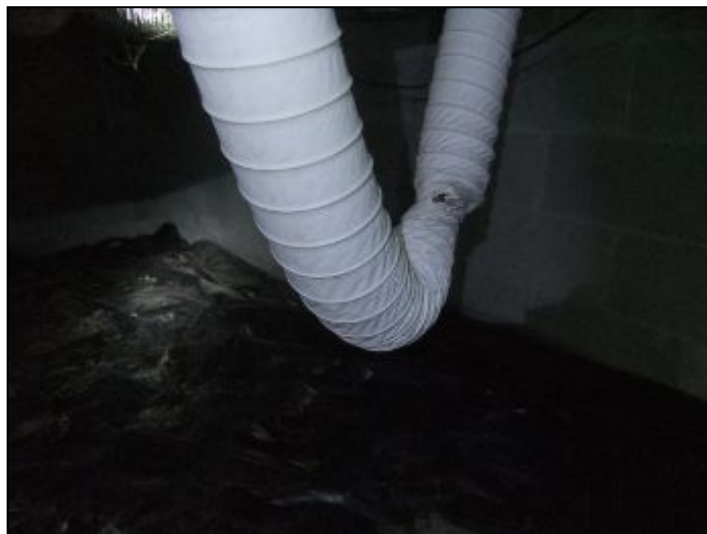
Dryer vent hose has hole. Replace with solid metal pipe

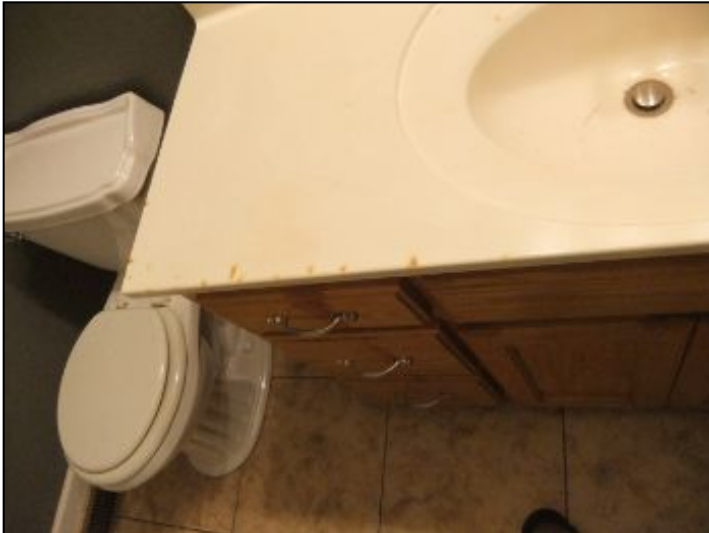
- Sink Faucet needs to be repaired.
- Cultured marble sink and top has burn marks on the edge.

burn marks on sink top

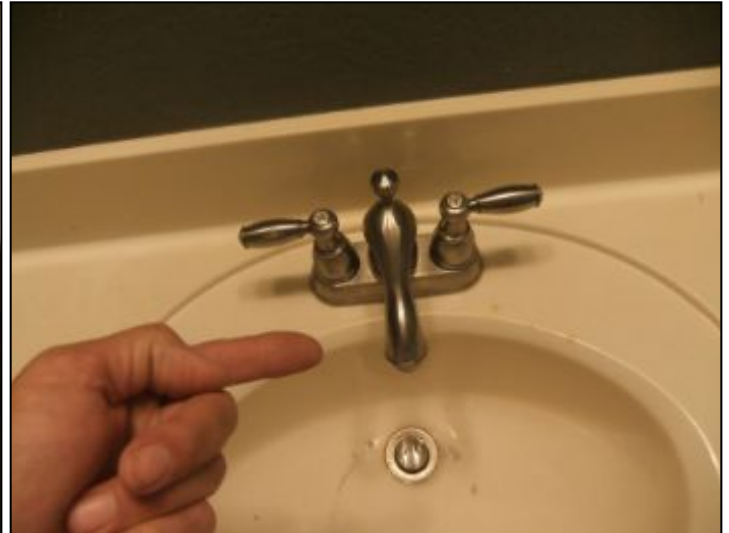
faucet needs repair

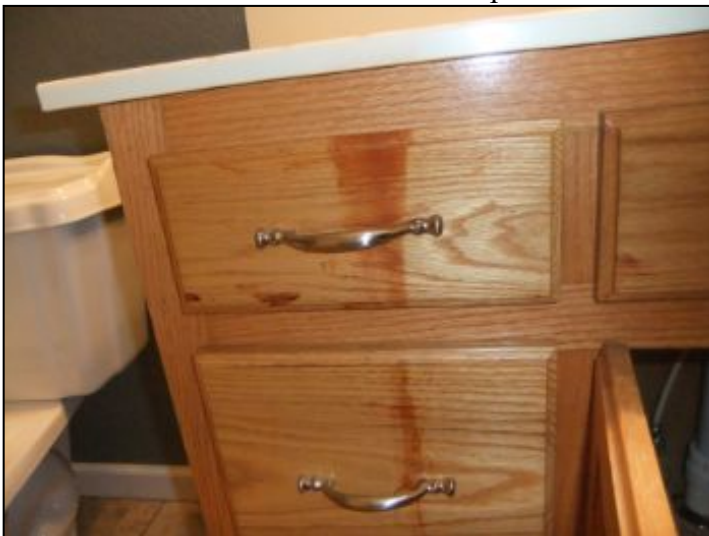
Wine on front of vanity

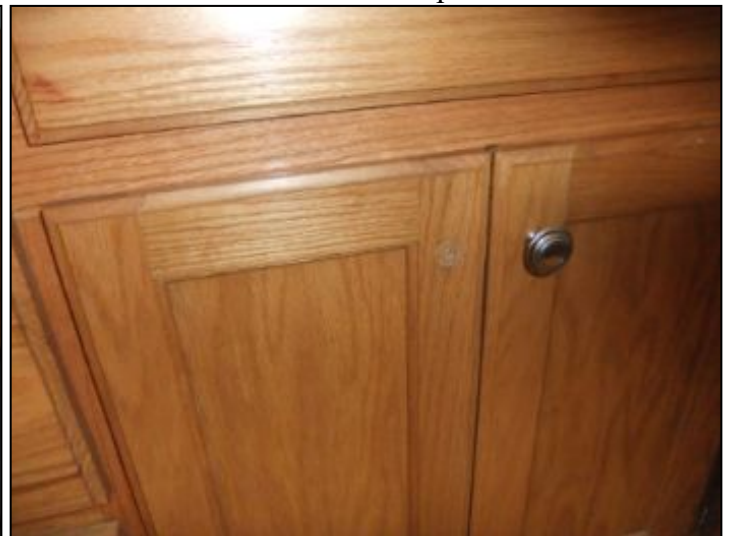
missing knob

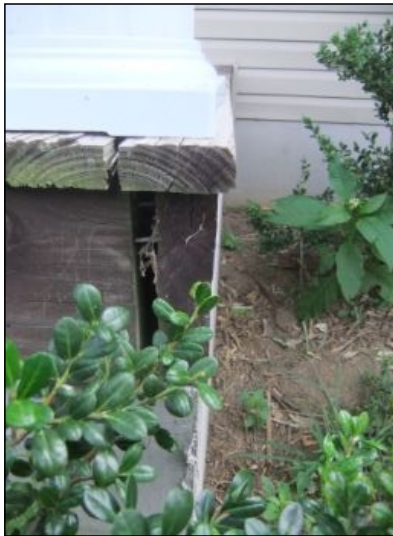
Rim board needs to reattached

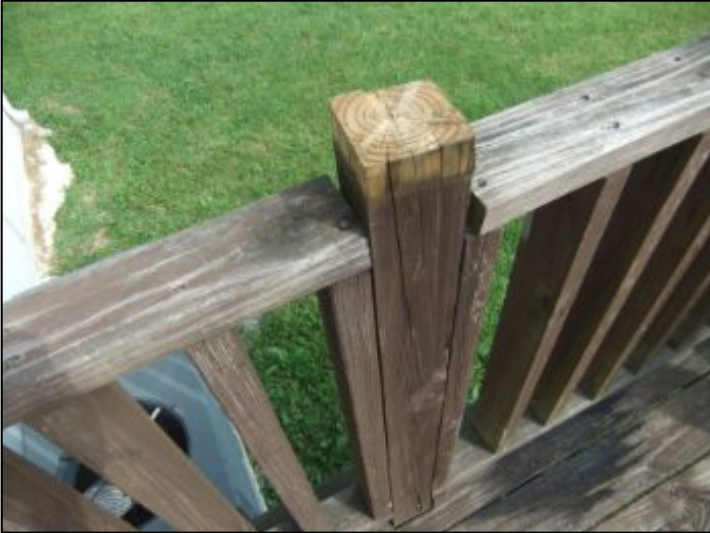
small nails at top of post need to be removed

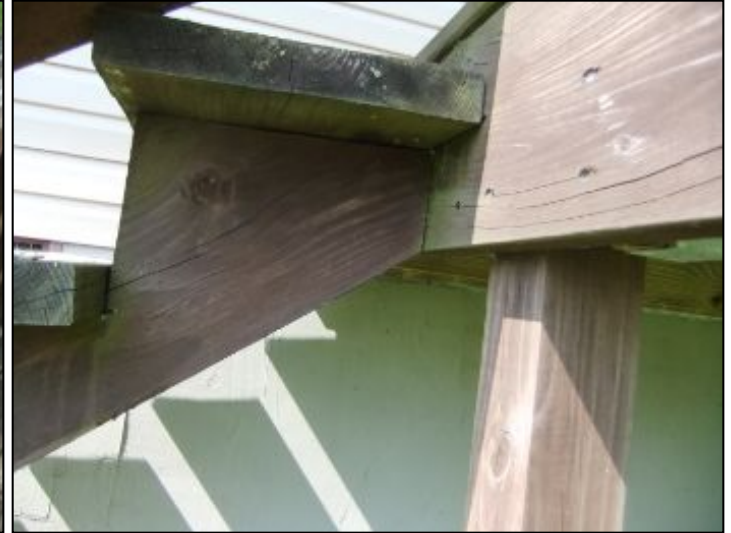
Stairs should have hanger attaching it to deck

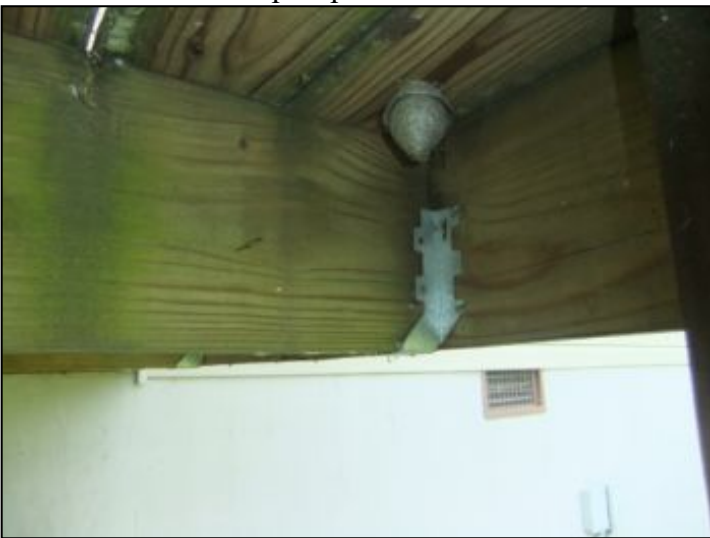
missing nails

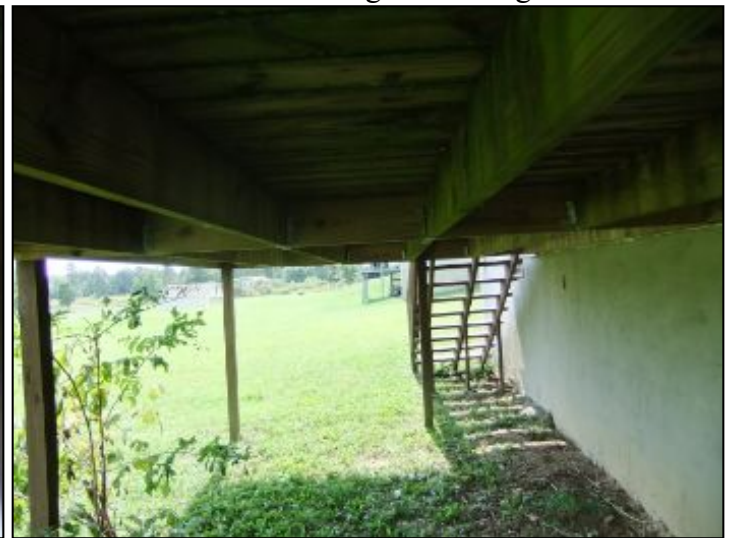
- Raised and exposed screws/nails are a hazard that need to be corrected.
- The deck is not stable, it moves when walked or with movement on the deck. Decks should not move from side to side. You should have the deck evaluated and the proper corrections made by a deck expert or contractor who specializes in decks.
- The deck hangers do not have nails going into the joists, add nails.
- Decking is in need of stain or other waterproofing measures to extend the life of the wood.
- **The center beam of the deck is deflecting from being undersized. An additional column is needed to support the beam.**

center beam deflecting

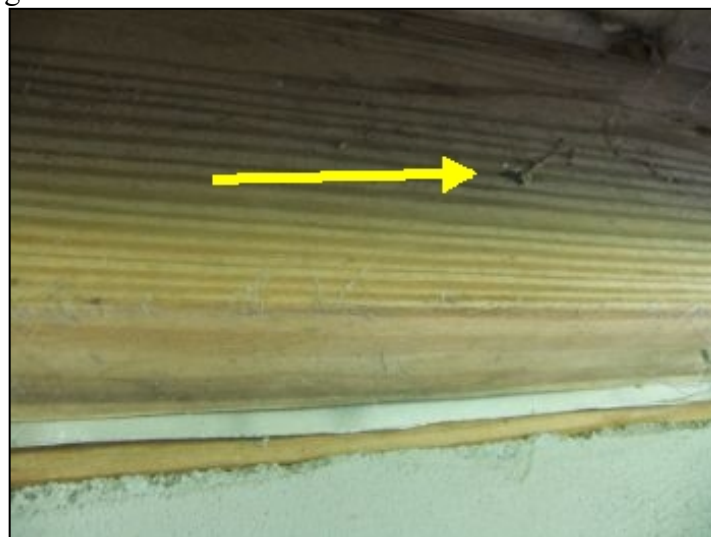
Ledger to house nails used instead of lag bolts. Add lag bolts or thru bolts.

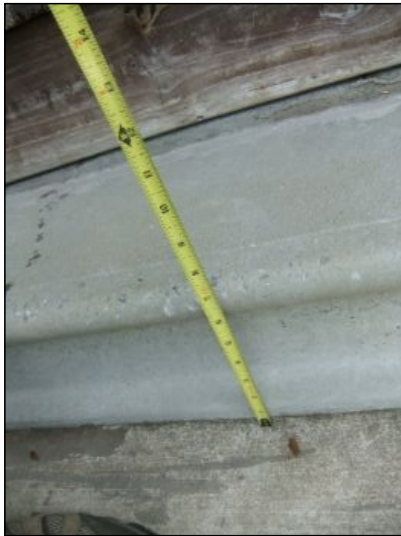
- Concrete step at front of house is not the same height from walkway to step and from the step to the porch, could create a tripping hazard.

7" at bottom step

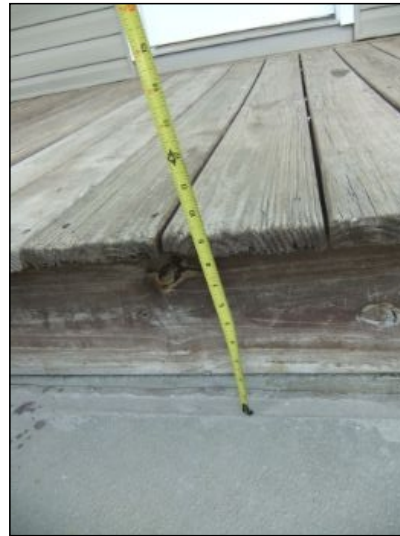
9 1/4" at top of step to porch

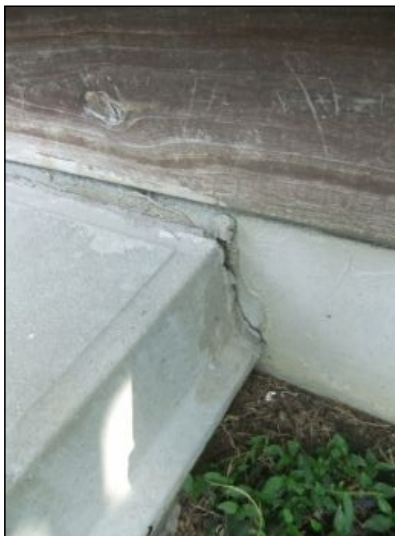
step slopes to house

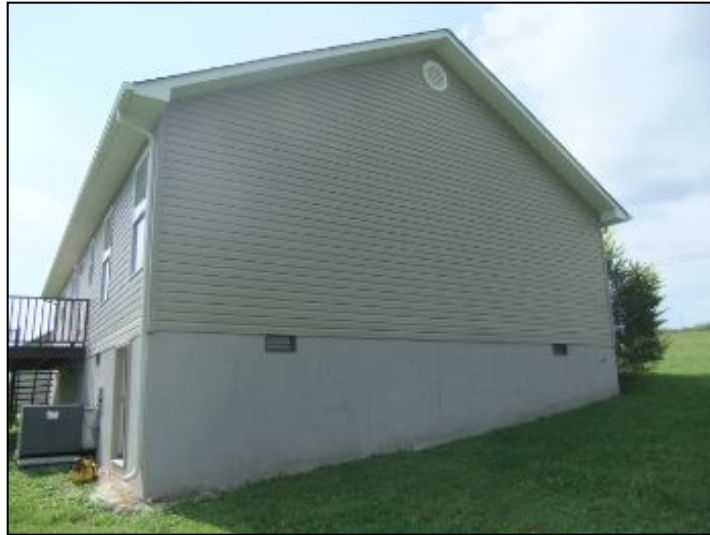
GROUNDS DRAINING AND GRADE CONDITIONS

- Based on what I'm seeing, it looks like water is flowing towards the homes foundation. This needs to be corrected so that the water flows away from the home.

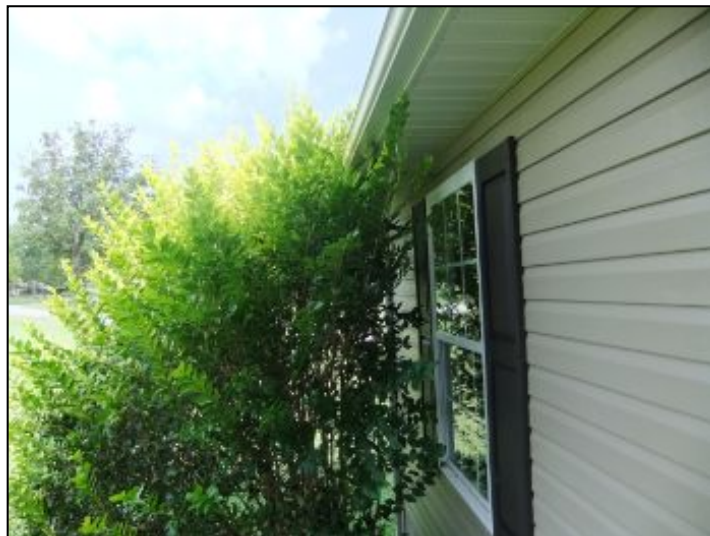
- Bushes are overgrown at front of house, plants need to be trimmed back away from the home.

Trim bushes
